Subj: COMMAND INVESTIGATION INTO THE FACTS AND CIRCUMSTANCES
SURROUNDING THE FIRE ONBOARD USS BONHOMME RICHARD (LHD 6) ON
OR ABOUT 12 JULY 2020

COMMAND INVESTIGATION

**INTO THE FIRE ABOARD
USS BONHOMME RICHARD (LHD-6)
12 JULY 2020**

5830
Memo N00/156
5 Apr 21

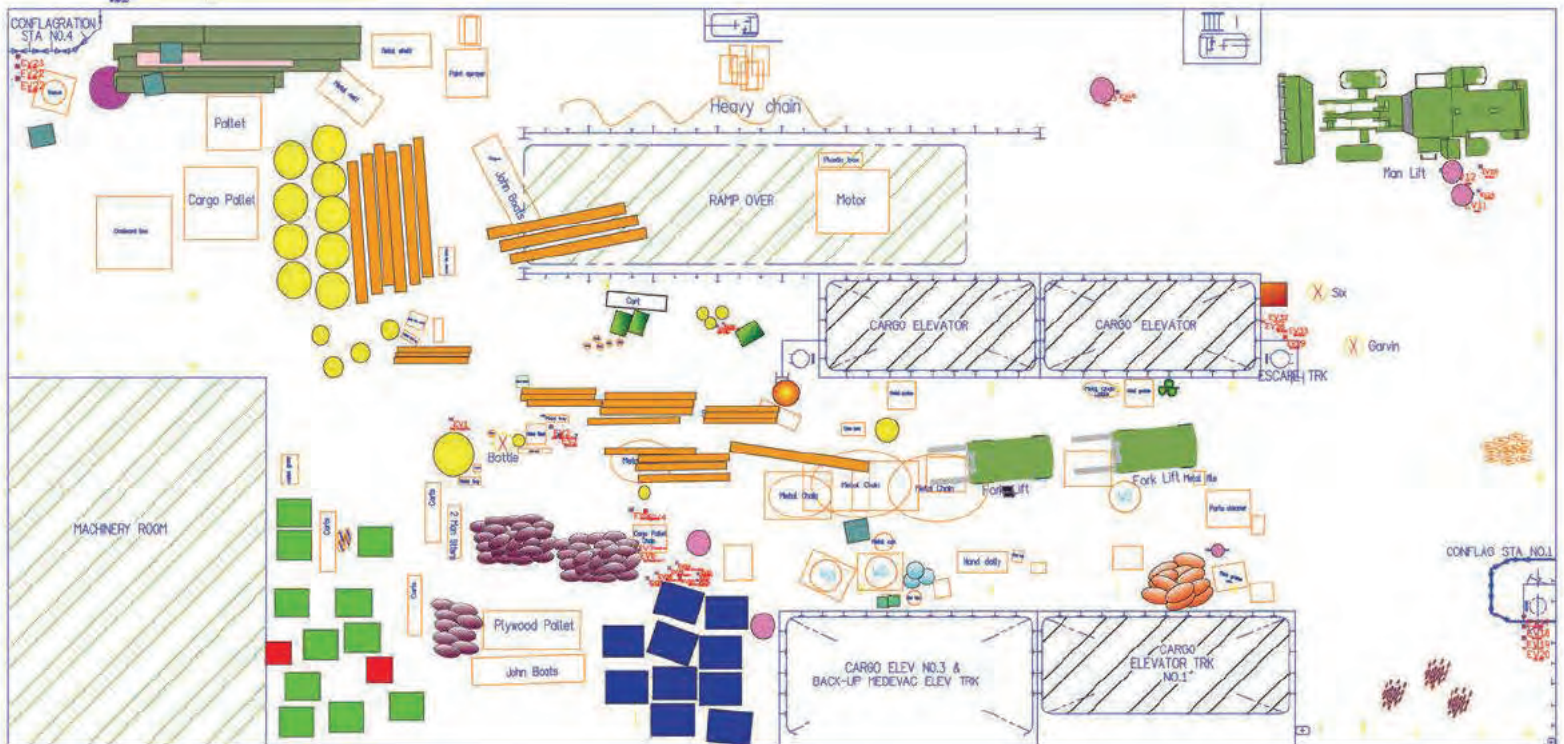
3. ATF determined that once the fire ignited, it spread to the significant amount of combustible material stored within Lower V (See Figure 1), which included dozens of tri-walls filled with gear and equipment and three fueled vehicles (a forklift, a man-lift, and a cargo tractor). [Encl 5]

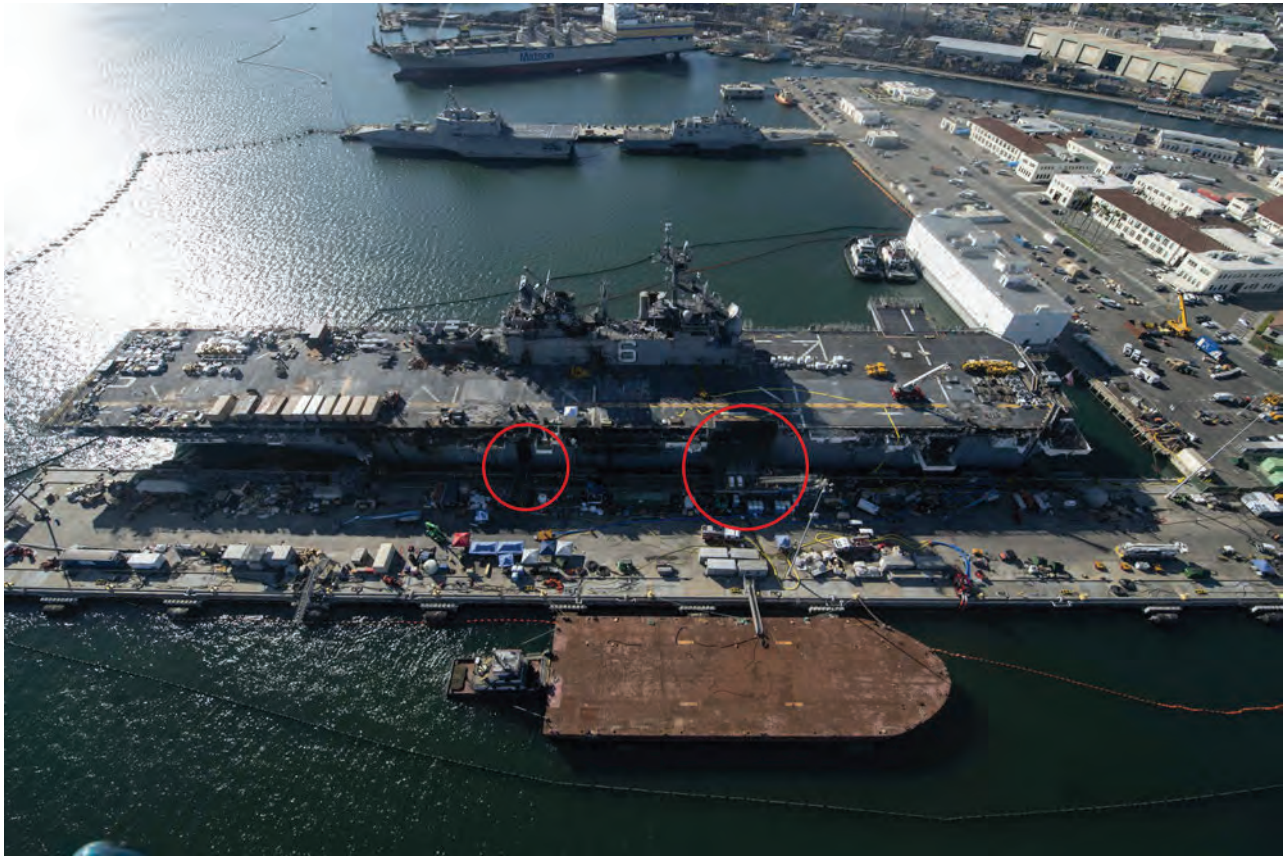
48. The first FEDFIRE unit arrived on the pier at 0829. FEDFIRE firefighters initially proceeded to the sideport door, as it appeared to be an easier access point; however, they did not observe any smoke emanating out of the sideport ramp, nor any Sailors stationed there. Shortly thereafter, BONHOMME RICHARD Sailors on the port Aircraft Elevator (ACE) redirected FEDFIRE to the Quarterdeck. Upon arrival at the port ACE Quarterdeck, the CDO briefed FEDFIRE that the location of the fire was unknown, and that the ship had also detected a B Phase ground. FEDFIRE radioed the RDC and reported the location of the fire was unknown but thought to be on the main deck. [Encl 70, 126, 139, 140, 146, 147, 148, 149, 150]

Figure 5 is a photograph of BONHOMME RICHARD with the sideport door/port ACE identified.

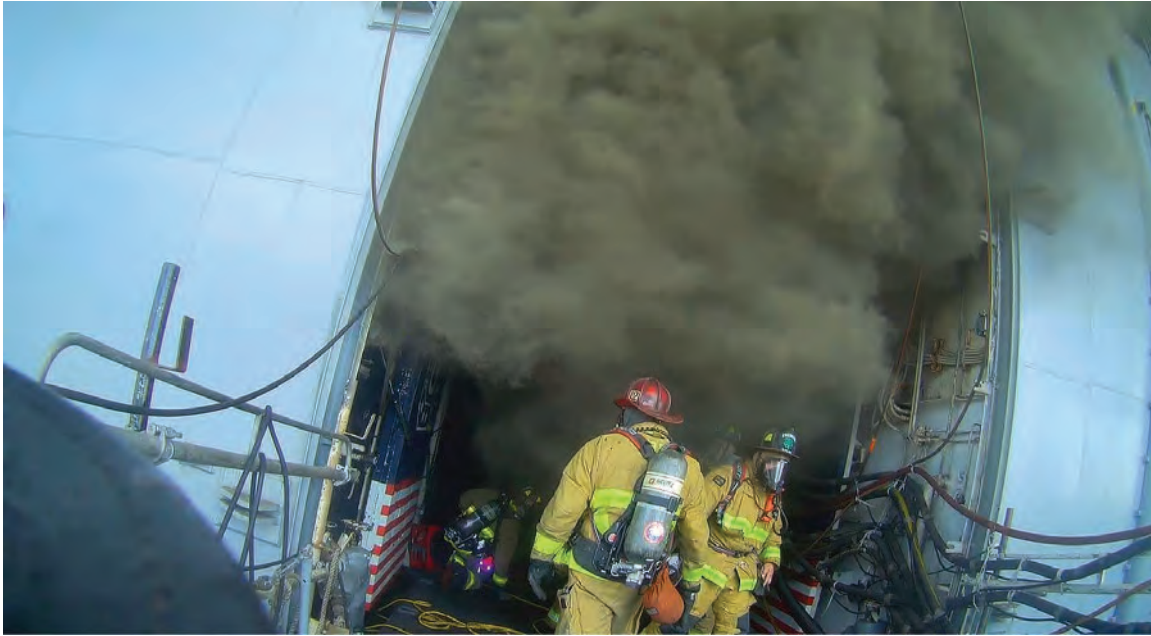
94. As the firefighting efforts continued, SDFD (b) (6) and SDFD (b) (6) observed smoke conditions were deteriorating. The fire transitioned to producing heavy black smoke with a yellow tinge, and multiple SDFD firefighters observed smoke being pulled back into the ship. At approximately 1035, SDFD (b) (6) informed the Assistant Operations Chief, NCFD (b) (6), that firefighters had "lost the space" (referring to Upper V). He then informed the firefighting teams, "This compartment is about to blast, get what you can, get what you can." NCFD (b) (6) radioed his concerns to SDFD (b) (6) and announced his intention to begin withdrawing the attack teams from the ship. Additionally, FEDFIRE (b) (6) received a report from FEDFIRE (b) (6) about the change in smoke conditions. FEDFIRE (b) (6) also noticed the smoke had become very heavy and black. Based on these reports, FEDFIRE (b) (6) also made the call to evacuate and pull all gear off the ship. At 1037, the ICP officially ordered all firefighting teams to evacuate BONHOMME RICHARD. [Encl 126, 141, 148, 164, 181, 229, 230, 239, 240, 241]

Figure 12 shows a screen capture from SDFD Firefighter (b) (6)'s helmet-mounted camera footage, illustrating smoke conditions at approximately 1035.

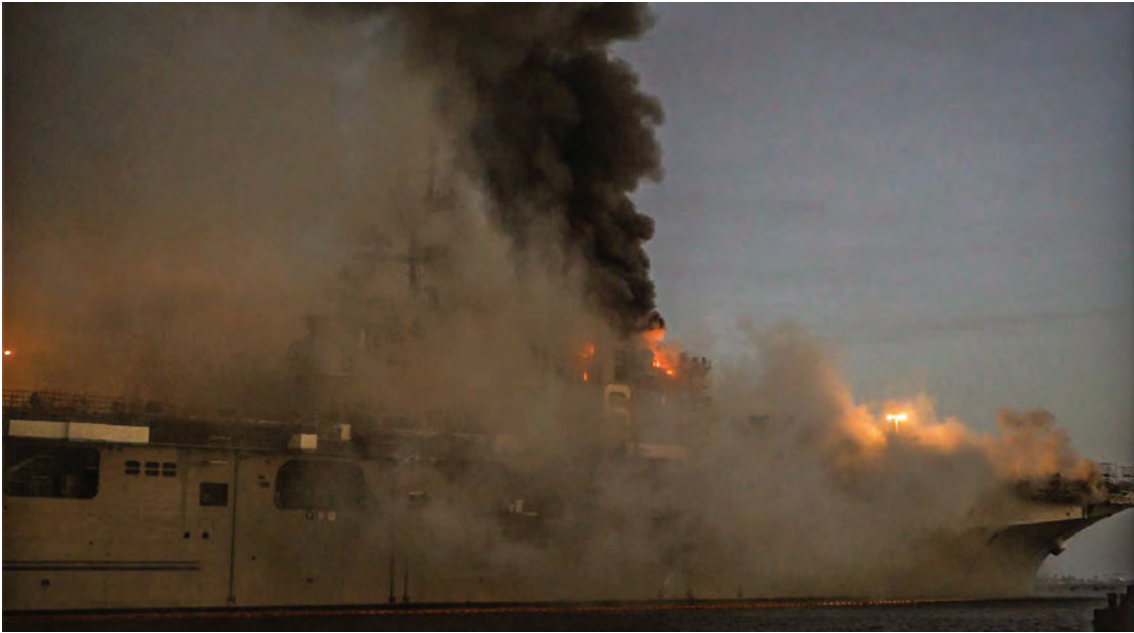
160. At 1954, the fire was observed to be venting out of the superstructure and continued to burn out of control, with an active fire visible from BONHOMME RICHARD's stacks. There were no FEDFIRE personnel or Sailors aboard BONHOMME RICHARD at this time. [Encl 249, 297, 377, 384]

Figure 15 shows BONHOMME RICHARD burning in the evening on 12 July 2020.

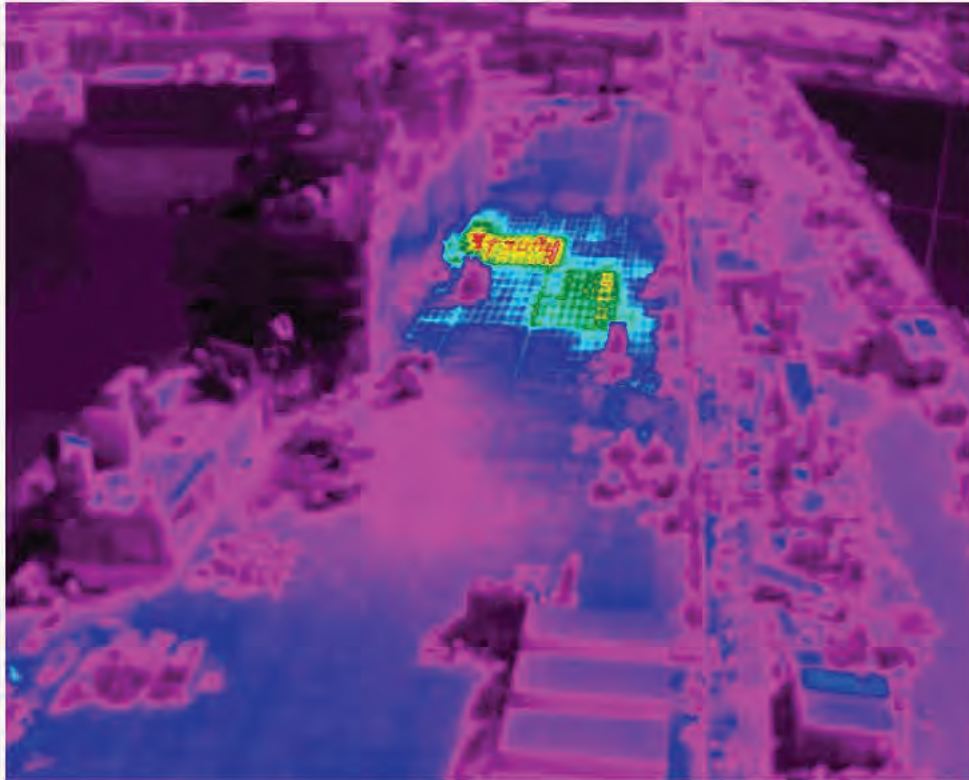
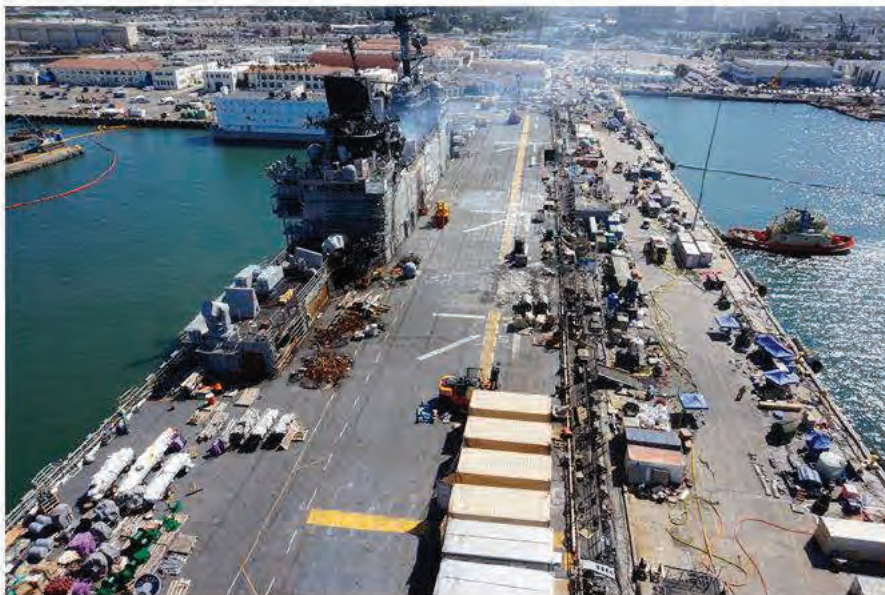
NBSD approval. This drone was subsequently used to identify hot spots for targeted firefighting efforts. US Fire Pump recommended cutting targeted holes in the ship to gain access to compartments with excessive heat or active fire. The first cuts started later that day at approximately 1737. [Encl 34, 141, 249, 314, 392, 394, 407, 409, 410, 411, 412, 413]

Figure 19 show US Fire Pump forward-looking infrared (FLIR) imagery of BONHOMME RICHARD, compared to a standard photograph taken simultaneously by the same drone.

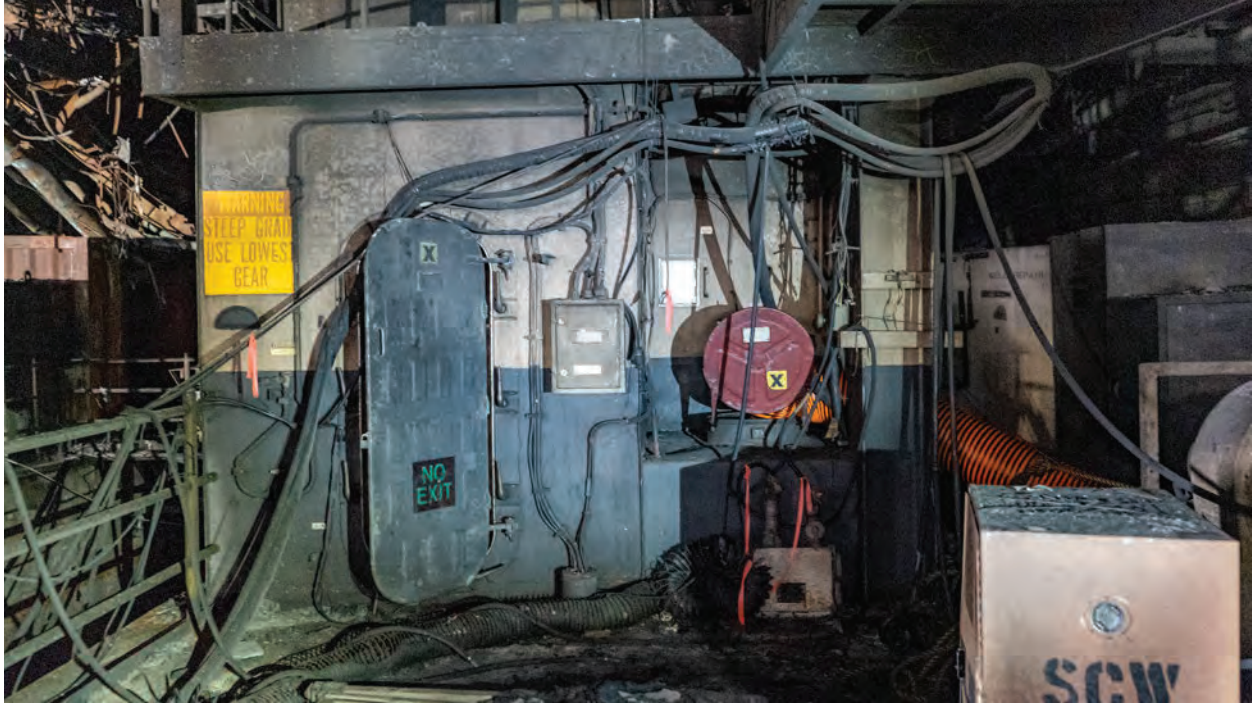
393. None of the 100 IET drills conducted from 23 July 2019 to 12 July 2020 employed AFFF. [Encl 44, 574]

Figure 29, Still photo of AFFF push-buttons for sprinkler groups 15 and 16 serving Lower V (16 on left; 15 on right). These push-buttons are in Upper V amidships. An open hatch obstructs visibility of the push-buttons.

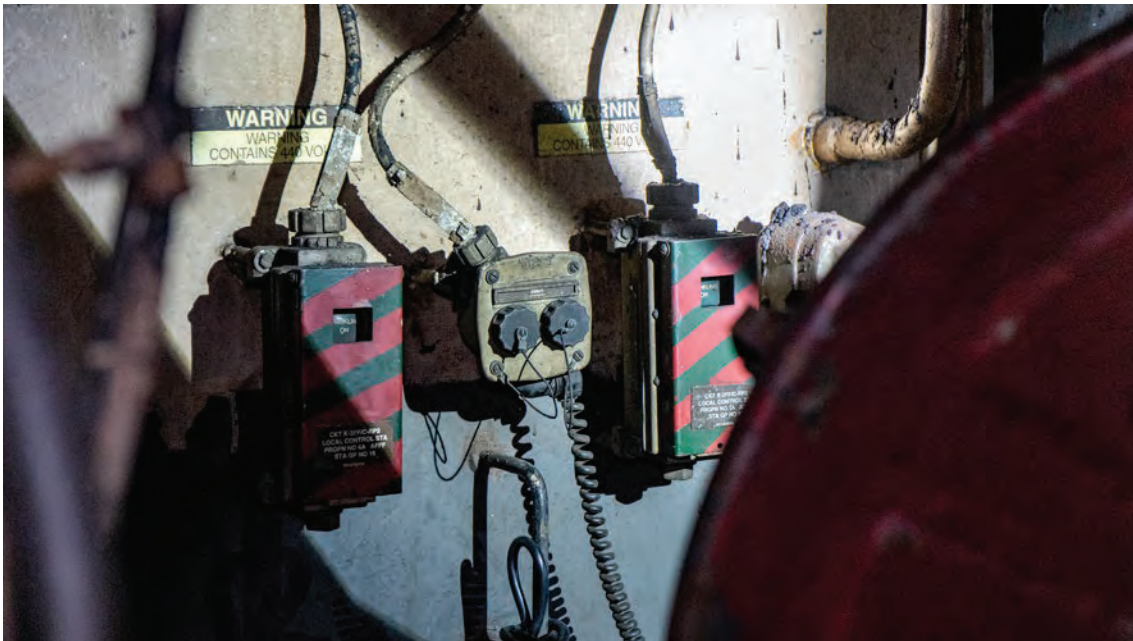
Figure 30, Still photo of AFFF push-buttons for sprinkler groups 15 and 16 serving Lower V with covers closed (16 on left; 15 on right). These push-buttons are in Upper V amidships. The photo shows proximity to open hatch, which obstructs visibility of the push

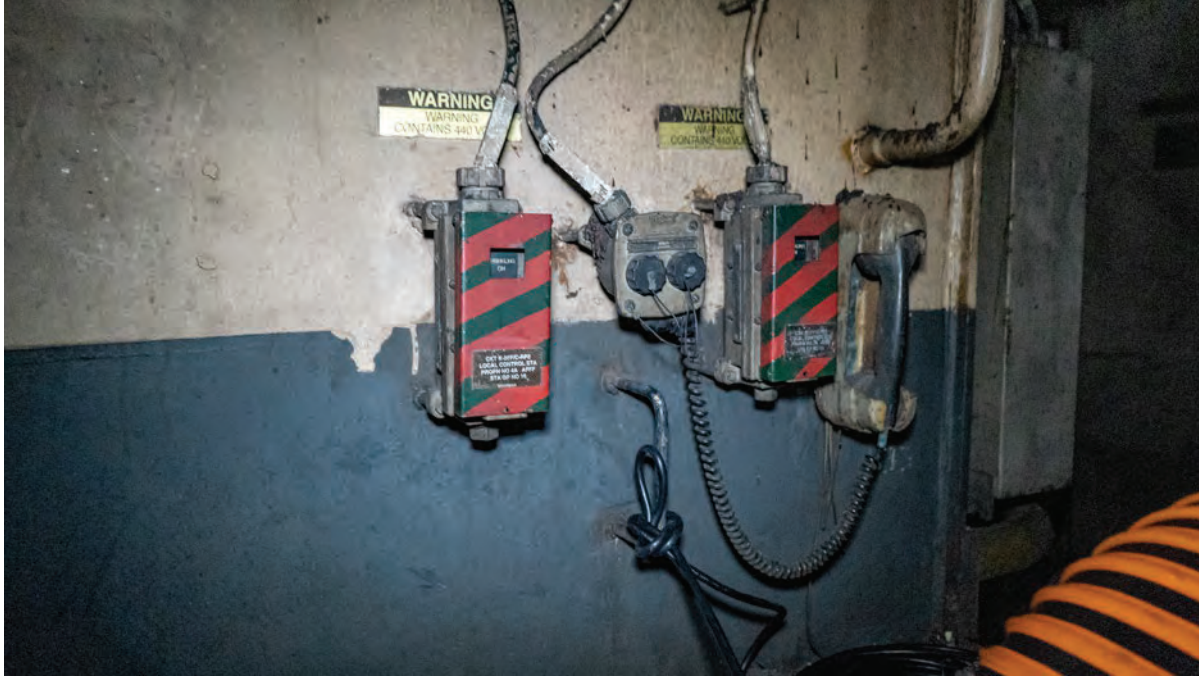
Figure 31, Still photo of AFFF push-buttons for sprinkler groups 15 and 16 serving Lower V with covers closed (16 on left; 15 on right). These push-buttons are in Upper V amidships.

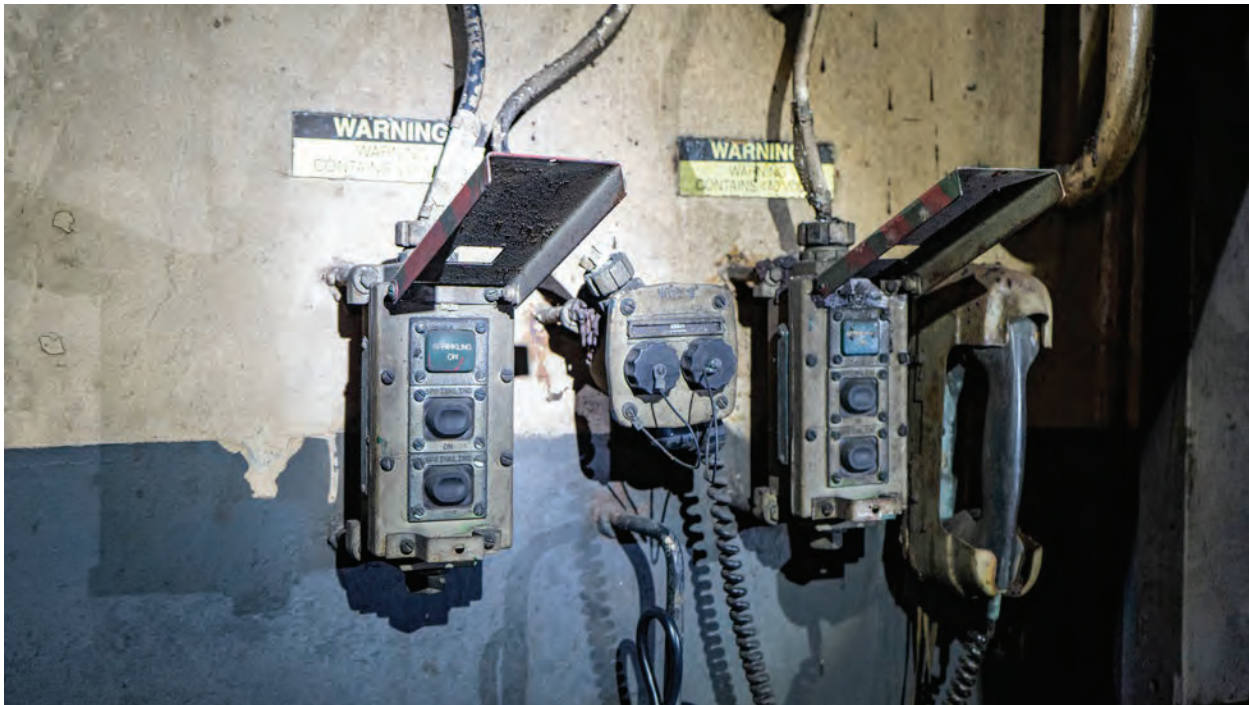
Figure 32, Still photo of AFFF push-buttons for sprinkler groups 15 and 16 serving Lower V with covers open (16 on left; 15 on right). These push-buttons are in Upper V amidships.
