Section IX: Resulting Condition of BONHOMME RICHARD

1039. The fire caused extensive damage and equipment loss throughout USS BONHOMME RICHARD (LHD-6). In the immediate aftermath of the fire, Naval Sea Systems Command (NAVSEA), NAVSEA21, and NAVSEA05 conducted a stem-to-stern fire damage assessment report (subsequently referred to as the “Material Assessment” (MA)). In addition to cataloguing the damage, the MA assessed the material condition and structural integrity of the ship as a precursor to the process of developing plans and options to inform the feasibility of repair and restoration. The initial MA report was completed on 1 August 2020. [Encl 731, 994]

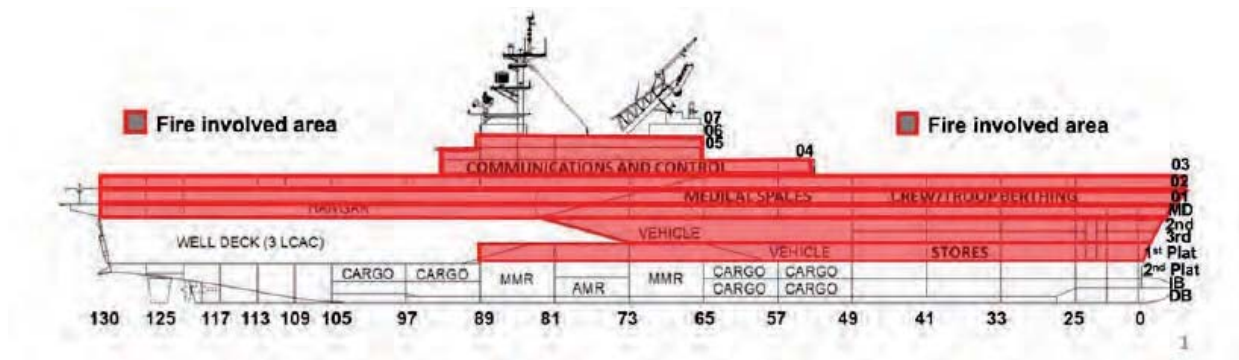
1040. To determine the full scope of damage to BONHOMME RICHARD, the MA initially divided the ship into zones, with the intent to assess each compartment within a respective zone for structural, fire/heat, or water damage. Due to the catastrophic nature of the actual damage conditions, the MA modified their initial compartment-by-compartment assessment to instead provide a gross assessment of groups of compartments. In many areas, the damage was so extensive that the MA was unable to identify specific compartments, as the fire and explosions created large open areas spanning several decks. Overall, the MA concluded that approximately 63 percent of BONHOMME RICHARD was impacted by the fire. [Encl 731, 994]

Figure 41 is a MA diagram indicating the fire-involved areas of BONHOMME RICHARD.

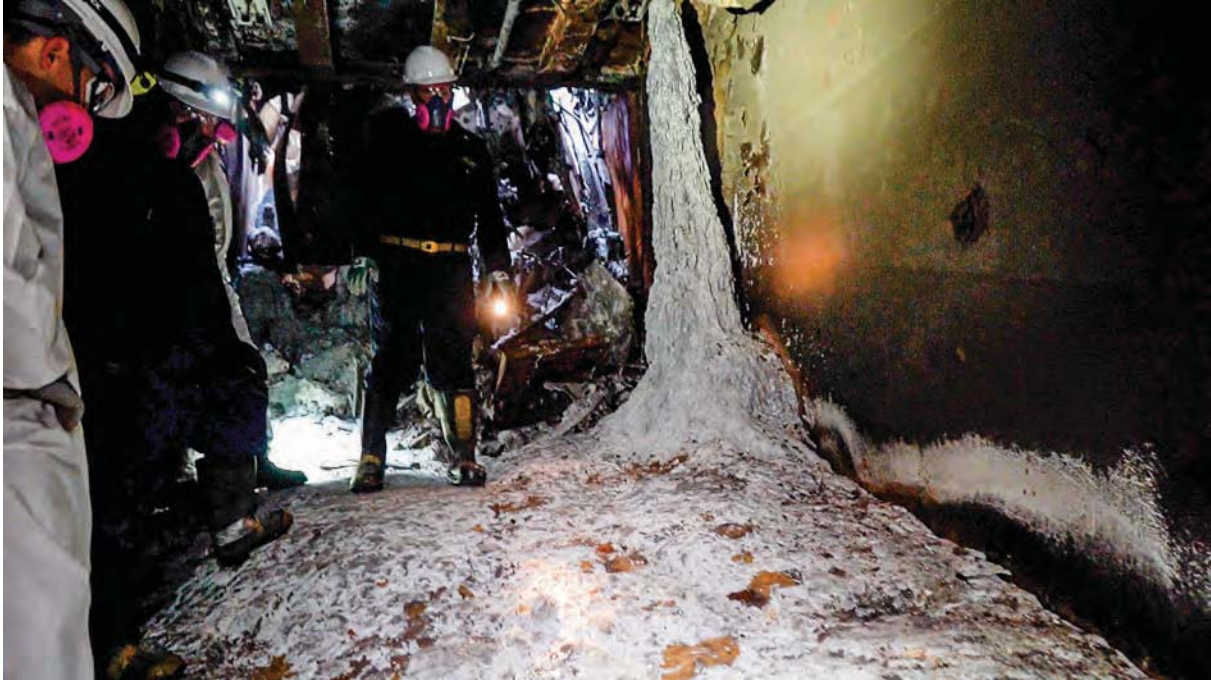
1041. The damage to the island is particularly notable, as the interior of the island is constructed primarily of aluminum, which has a lower melting point than carbon steel. The island was completely hollowed-out by the fire, transforming nearly a third of the 300-ton structural mass into molten aluminum. This molten aluminum drained through the island’s Flight-Deck level foundation penetrations onto the decks below, creating lava-like flow across lower-level steel decks and through vertical deck penetrations. No material remaining within the island is salvageable, as the fire essentially left exterior bulkheads with no other support structure. Due to the lack of structural integrity, should the ship be towed on the open-ocean, the island must either be removed or buttressed. [Encl 731, 995, 996, 997, 998]

Figure 42 shows investigation team members examining a solidified aluminum flow.

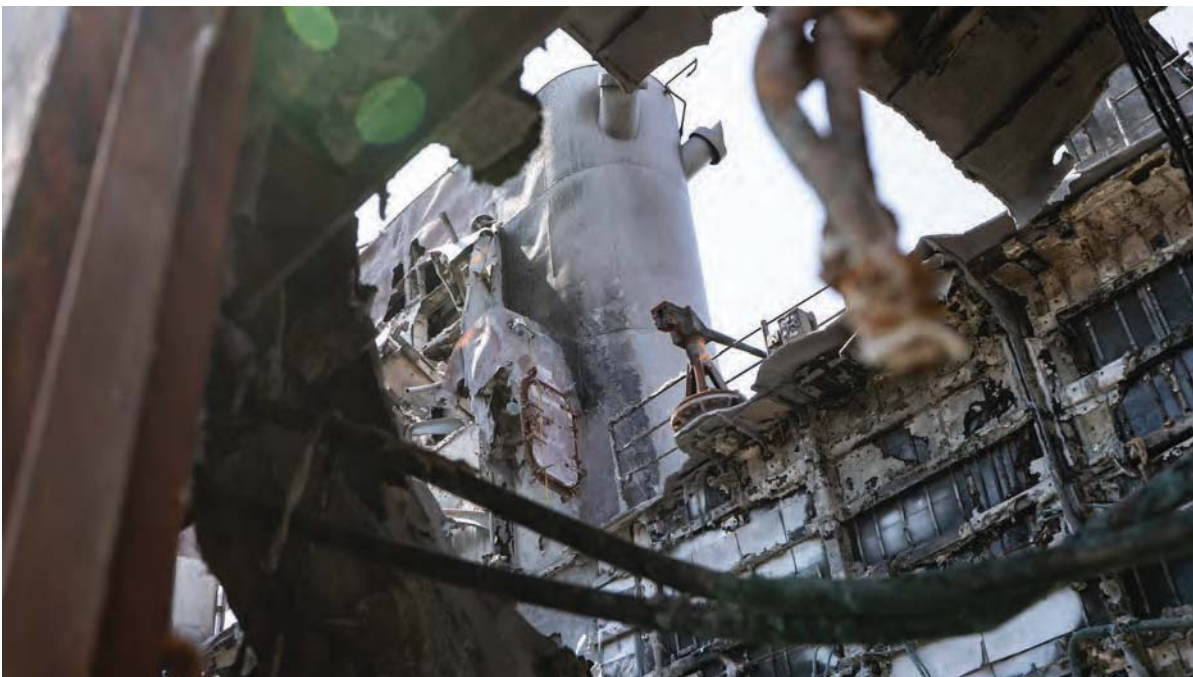
1042. As noted above, the loss of the interior island structure compromised the island's structural integrity, leading to the collapse of the forward mast and necessitating the removal of the aft mast in the weeks after the fire. [Encl 731, 999, 1000]

Figure 43 shows the island's interior, illustrating that the overhead has completely burned away.

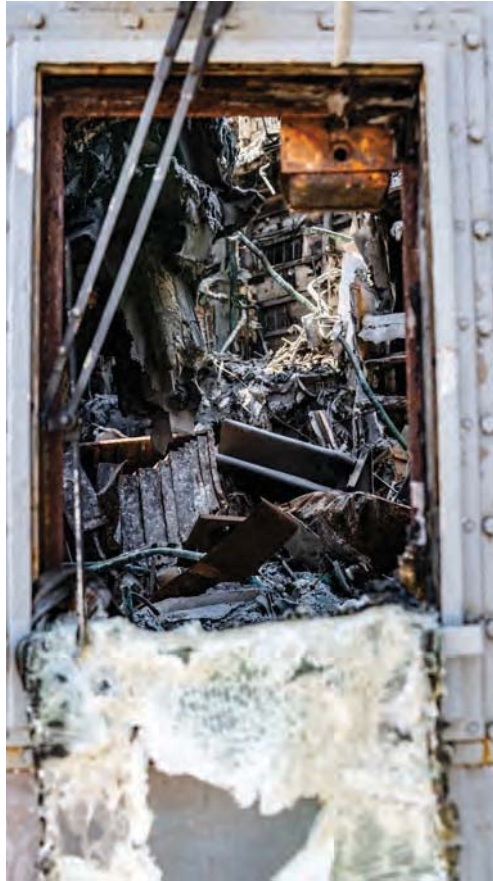
Figure 44 is another photograph of the island's interior.

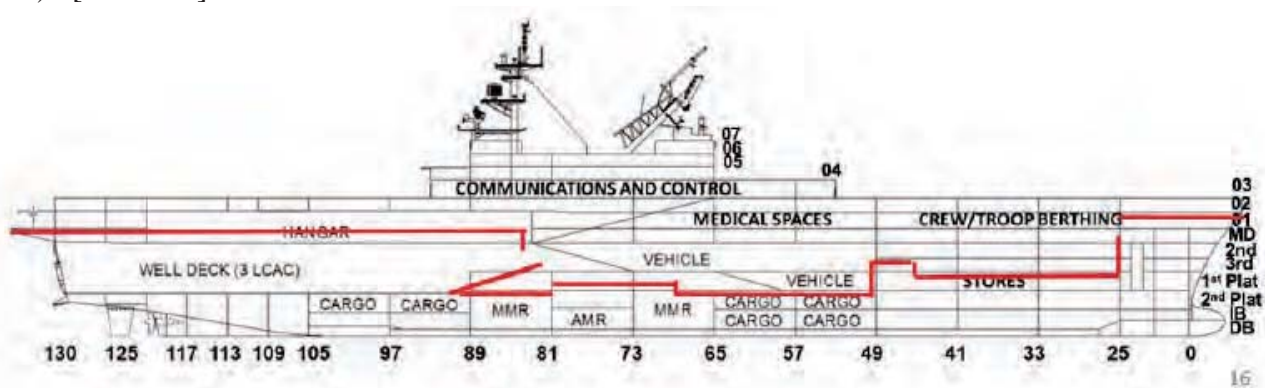
1046. To aid in repair calculations, the MA established an approximate “cut-line,” above which virtually no compartment is salvageable. The MA concluded that restoration above the cut-line would entail the removal and replacement of entire decks, compartments, and all associated contents and equipment. Major spaces above the cut-line include: the island structure, all 02-level compartments for the entire length of the ship, all 01-level compartments from Frame 25 to the stern, all compartments on the Main Deck from Frames 25 to 89. Key spaces below the cut-line that still require total replacement include Damage Control (DC) Central (5-79-0-C, Ship’s Laundry (4-73-0-Q), Upper Vehicle Stowage Area (Upper V) (3-49-0-A) and Lower V (4-49-0-A). [Encl 731]

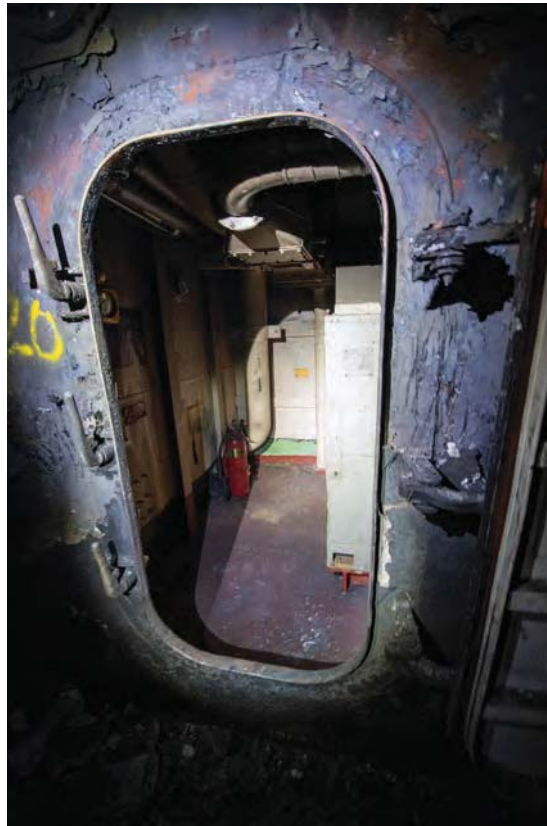
1048. In various areas throughout BONHOMME RICHARD, there is a stark distinction in the severity of damage between neighboring compartments, with one compartment heavily damaged and the other much less affected. This appears to have occurred primarily where any openings between the two compartments (such as hatches and scuttles) were closed, preventing the spread of heat, smoke, and flames. [Encl 1002]

Figure 47 shows two compartments separated by a closed hatch. One compartment was severely damaged, while the adjacent compartment suffered minor damage.
