# Major Fires Review

## Executive Summary

Commander, U.S. Fleet Forces Command

July 15, 2021

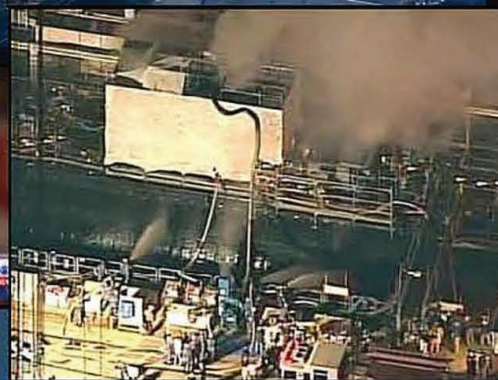
**Bottom center:** The USS Miami (SSN 755) was severely damaged by a fire that broke out on May 23, 2012 in the Portsmouth Naval Shipyard. (U.S. Navy photo, CBS Boston/AP online article)

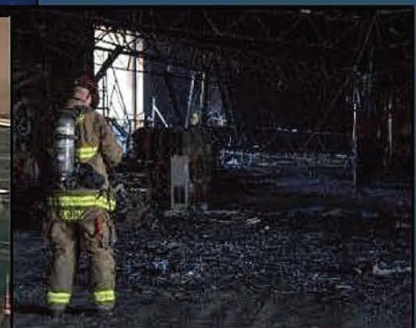
**Bottom right:** Federal firefighters assess damage in the hangar bay aboard the amphibious assault ship USS Bonhomme Richard (LHD 6) on July 15, 2020. (U.S. Navy photo)
