Subj: COMMAND INVESTIGATION INTO THE FACTS AND CIRCUMSTANCES
SURROUNDING THE FIRE ONBOARD USS BONHOMME RICHARD (LHD 6) ON
OR ABOUT 12 JULY 2020

COMMAND INVESTIGATION

**INTO THE FIRE ABOARD
USS BONHOMME RICHARD (LHD-6)
12 JULY 2020**

5830
Memo N00/156
5 Apr 21

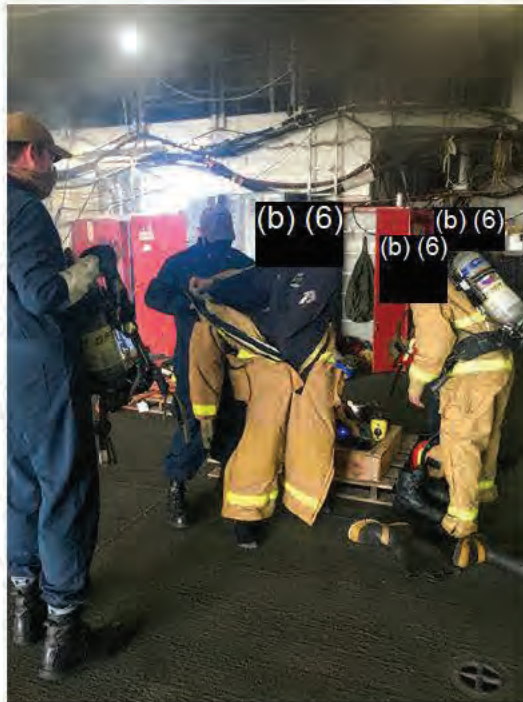
25. Following the 1MC announcement from the Quarterdeck, BONHOMME RICHARD Sailors began assembling in the Hangar and dressing out in SCBAs and Firefighting Ensembles (FFEs). Multiple Sailors, including several Chief Petty Officers (CPO), reported they did not dress out in FFEs because they were wearing the Type III Navy Working Uniform (NWU), rather than coveralls. The choice not to dress out was at least partially based on an assumption that it is not

Figure 3 captures BONHOMME RICHARD Sailors dressing out in the Hangar.

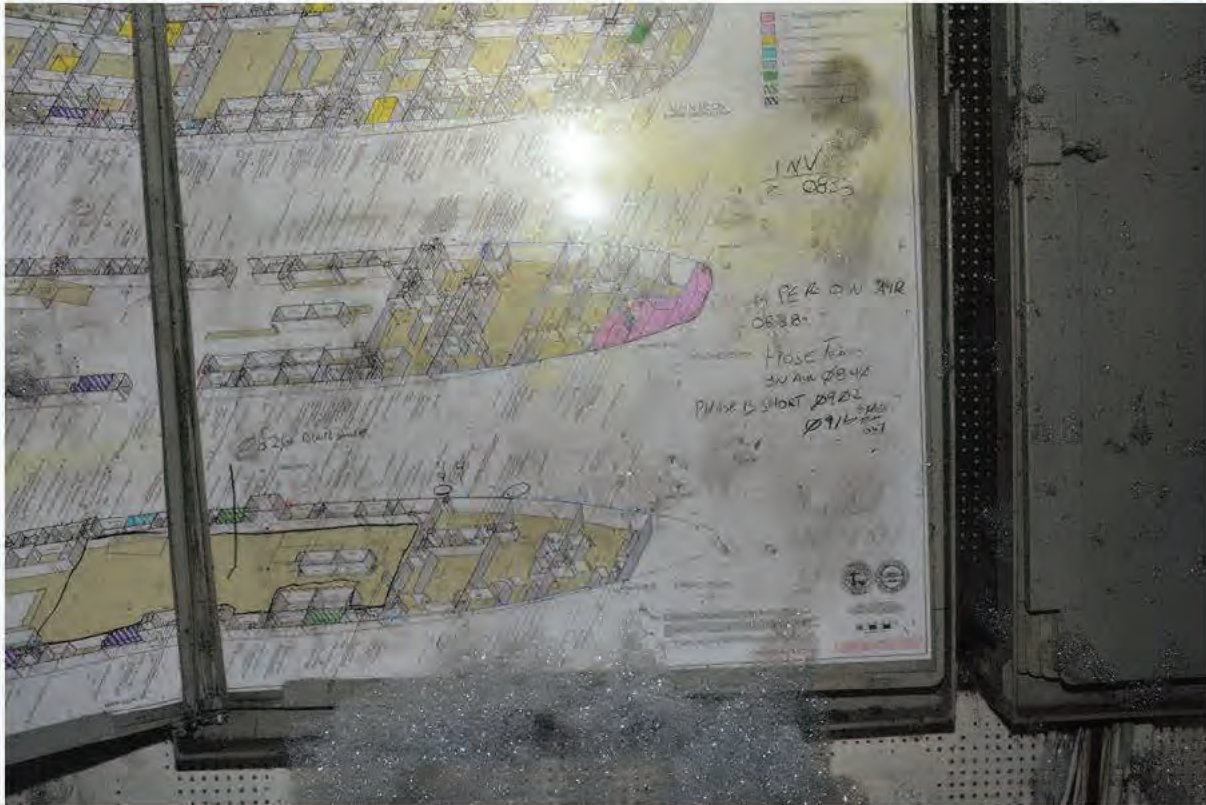
35. DC Central DC plates indicate that at 0838, a four-man team went donned SCBAs and went on air. At 0840, the DC Central DC plates indicate that a hose team went on air. In handwritten notes, the EDO also logged a six-man team on air at 0904. (See Figure 4, which depicts the BONHOMME RICHARD DC plates in DC Central). [Encl 69]

Figure 4 depicts the BONHOMME RICHARD DC plates in DC Central.

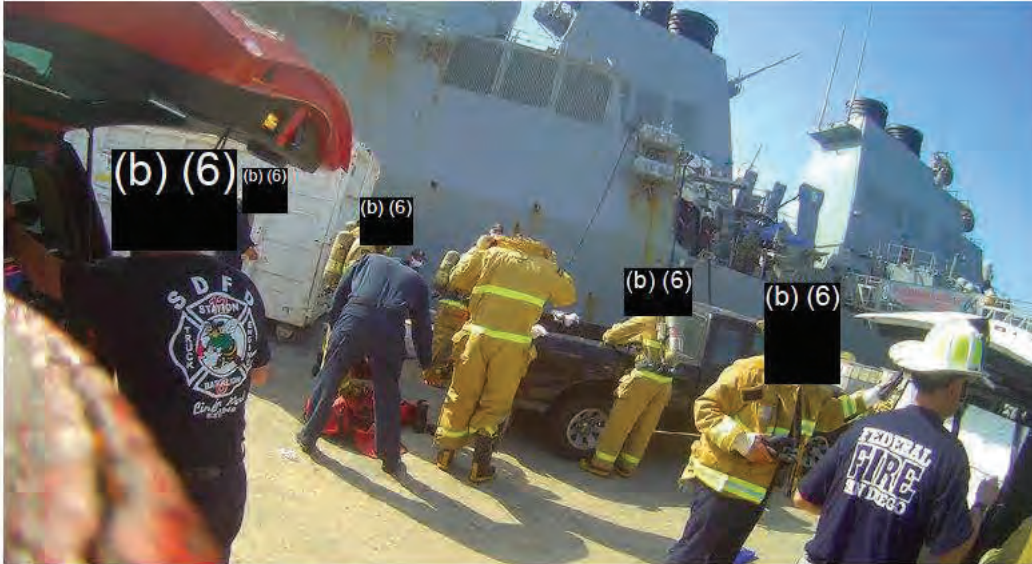
58. On arrival, SDFD met with FEDFIRE (b) (6), who had assumed the role of FEDFIRE Incident Commander (IC). (b) (6) directed SDFD to support FEDFIRE's attack via the port ACE. At this time, FEDFIRE did not provide SDFD any information about the fire other than they had not determined its location. By this time (0900), several BONHOMME RICHARD Sailors were aware of the fire's location. [Encl 126, 156, 166, 178, 179]

Figure 6 is a screen capture from SDFD (b) (6)'s helmet-mounted camera footage. The image shows the ICP (FEDFIRE and SDFD command vehicles with tailgates up) at approximately 0910.

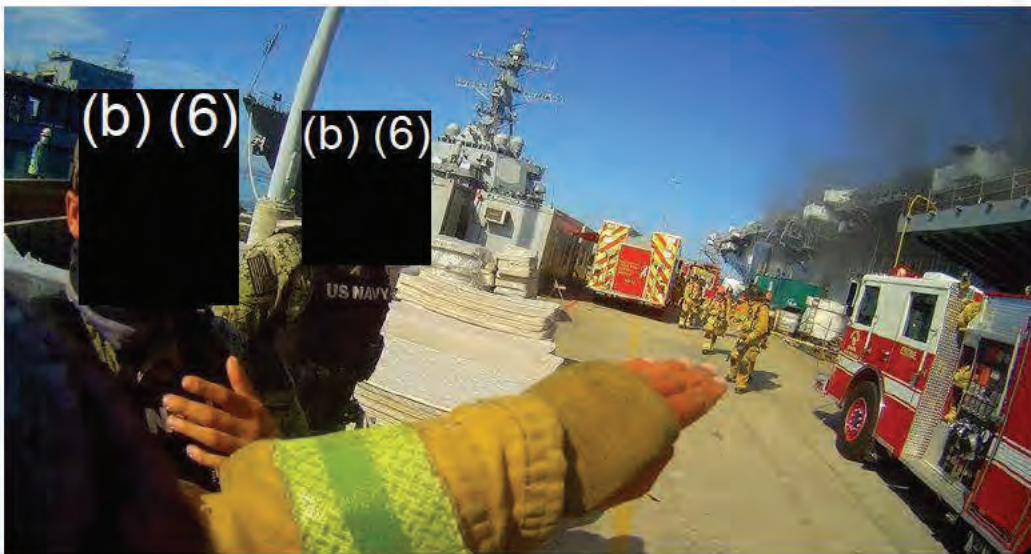
59. After arriving at 0900 and checking in with FEDFIRE (b) (6) near the entrance to Pier 2, SDFD (b) (6) walked down the pier and asked a Navy Sailor whether he knew where the fire was located. The Sailor replied that the fire was located either in Upper V or Lower V while pointing past the port ACE toward the sideport ramp. SDFD (b) (6) asked several personnel for a “map” of the ship but was unable to acquire one. [Encl 126, 166, 180]

Figure 7 is a screen capture from SDFD (b) (6)'s helmet-mounted camera footage. At approximately 0908, SDFD (b) (6) stopped Sailors to seek information about the fire.

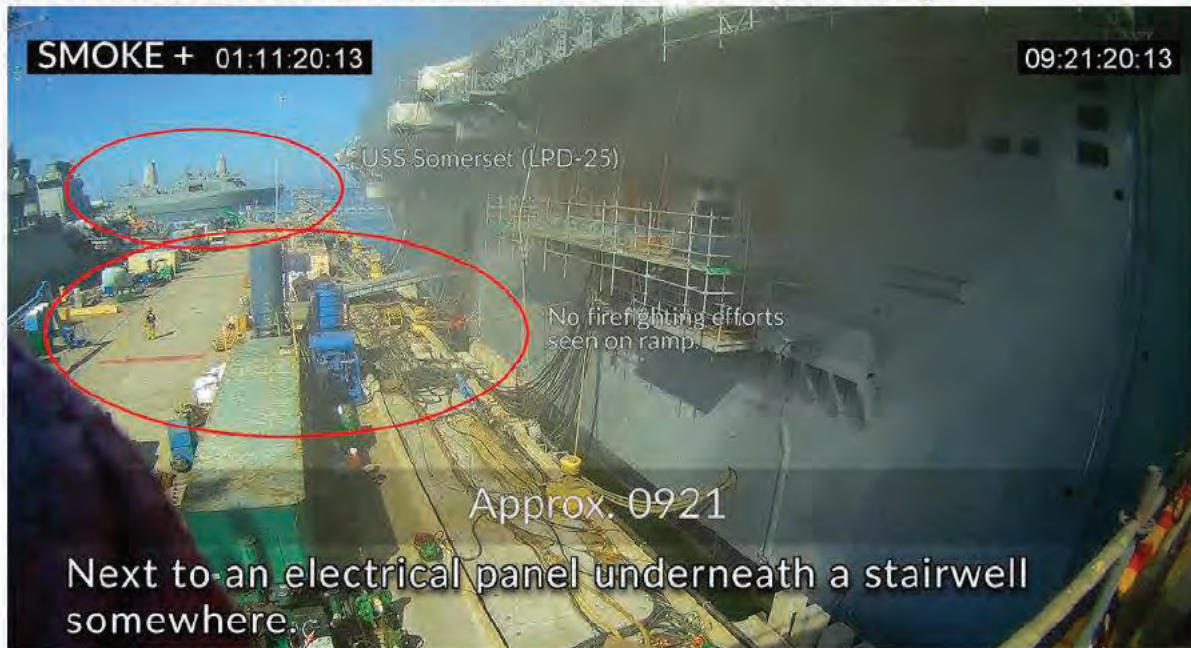
Figure 8 is a screen capture from SDFD (b) (6)'s helmet-mounted camera footage (subtitles and other text added by the investigation team). SDFD (b) (6) was speaking about the location of the fire. No personnel are visible by the sideport door.

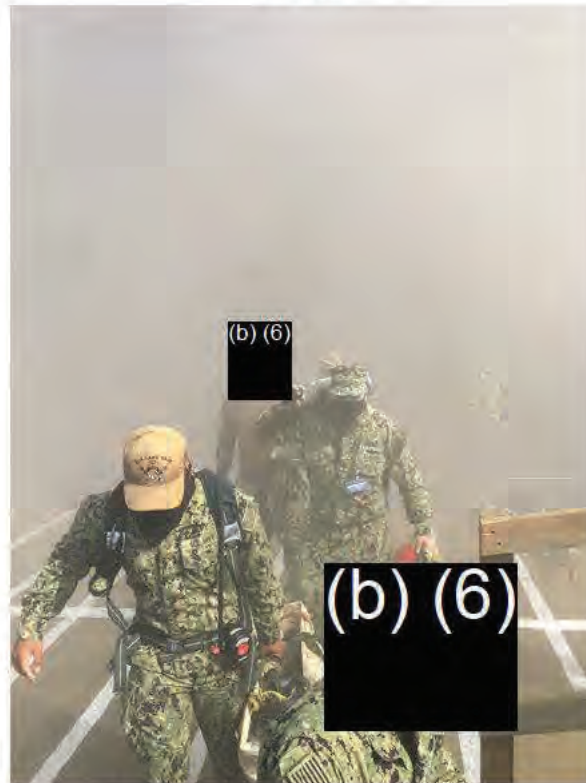
65. At approximately 0900, (b) (6) and RUSSELL's R&A team were directed to evacuate the Hangar due to smoke. They debarked and staged on the pier next to the sideport ramp. RUSSELL's team observed numerous BONHOMME RICHARD Sailors departing the ship. At approximately 0915, due to deteriorating smoke conditions in the Hangar, the CDO ordered all personnel not wearing SCBAs to evacuate the ship. Prior to issuing this order, the CDO spoke to BONHOMME RICHARD CO via phone and informed him that he (the CDO) was ordering the evacuation of non-SCBA wearing personnel. The CO concurred with this action and ordered the evacuation. There are varying reports on whether this evacuation order was communicated over the 1MC. [Encl 27, 41, 70, 98, 99, 142, 185, 195]

Figure 9 shows Sailors evacuating the BONHOMME RICHARD Hangar.

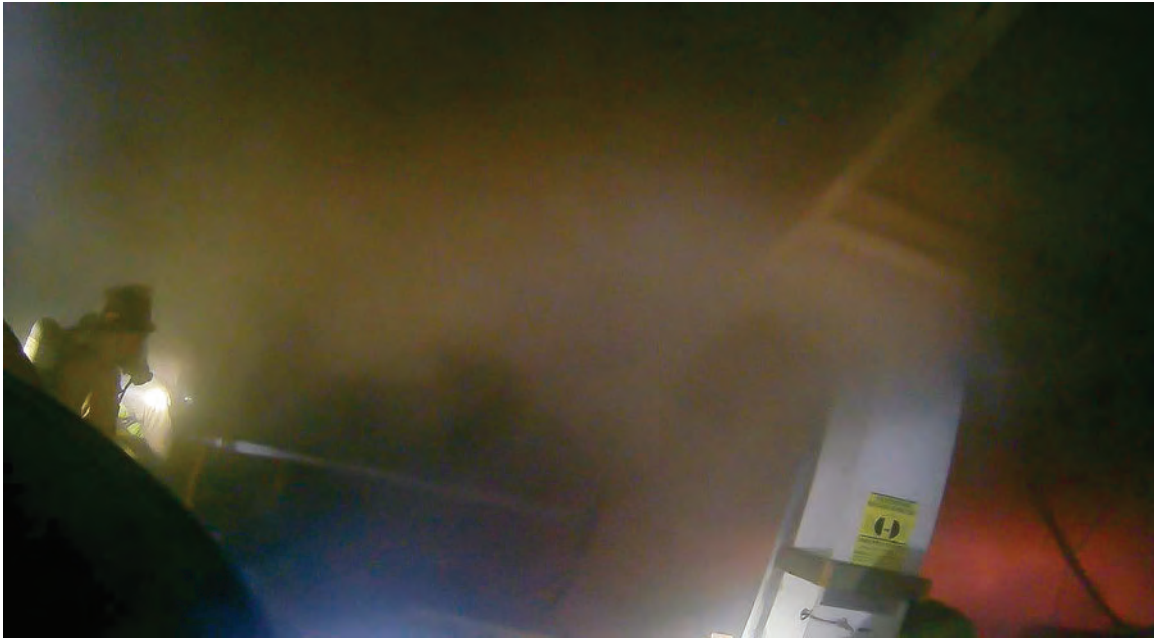
Figure 11 shows a screen capture from SDFD Firefighter (b) (6)'s helmet-mounted camera footage. This image captures the first time agent was applied to fire on 12 July 2020, as SDFD teams applied firefighting water to the radiant fire in Upper V at approximately 0951.

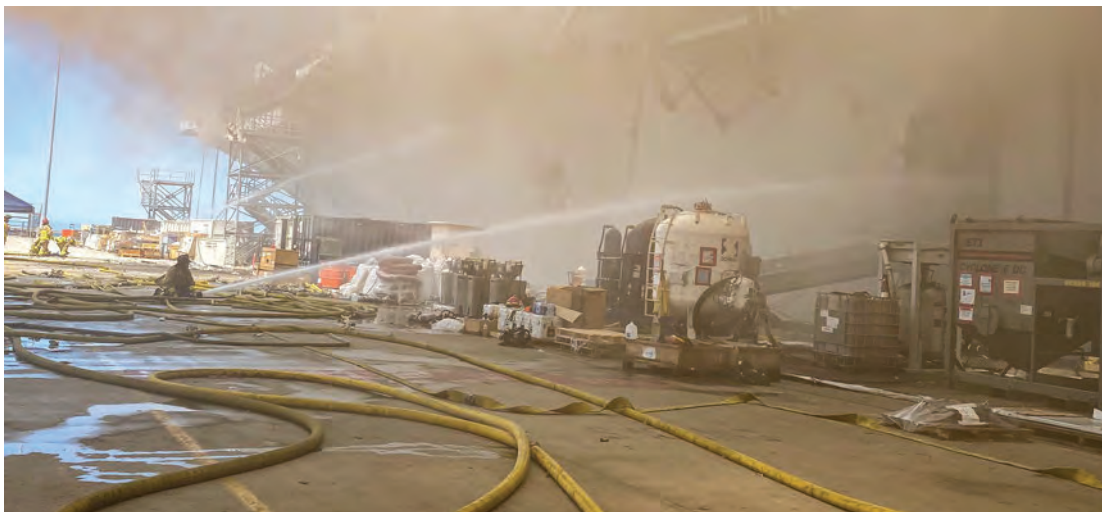
101. At approximately 1124, FEDFIRE personnel and several BONHOMME RICHARD Sailors, including the DCA, returned to Pier 2 to establish an unmanned monitor (fire nozzle) at the sideport door, which sprayed water directly into Upper V from the sideport door. FEDFIRE (b) (6) and FEDFIRE (b) (6) were the first FEDFIRE firefighters to return to the pier after the explosion. FEDFIRE (b) (6)’s team was tasked with leading a firefighting effort up to the Hangar (Division 1) while FEDFIRE (b) (6)’s team was tasked with leading a firefighting effort into Lower V (Division 2). Due to the intensity of the fire, Divisions 1 and 2 were re-tasked with evaluating the state of the fire and determining the feasibility of recommencing firefighting efforts. The fire’s intensity, heat, and a significant amount of debris forced the divisions to use a “round robin” approach to combatting the casualty. The teams departed just outside the ship and swapped out bottles before reentering and continuing to fight. [Encl 149, 189, 203, 257, 258, 259]

Figure 13 shows firefighting monitors spraying water from the pier on 12 July 2020.
